Subject: Pajaro Dunes GHAD Rock Revetment Maintenance Project Biotic Report Review

**Biological Assessment and Report for the
Pajaro Dunes Seawall Maintenance & Repair Project,
Watsonville, CA.**

Pajaro Dunes Geologic Hazard Abatement District

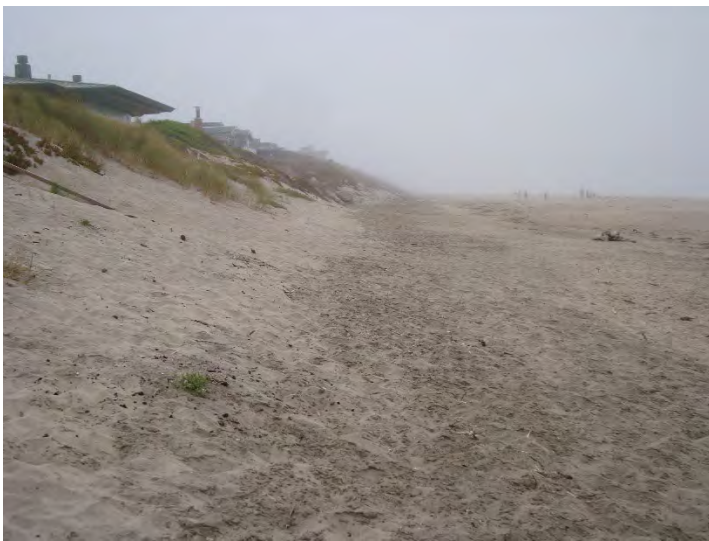
Figure 4. View southward showing sparsely vegetated beach and foredune, July 2024

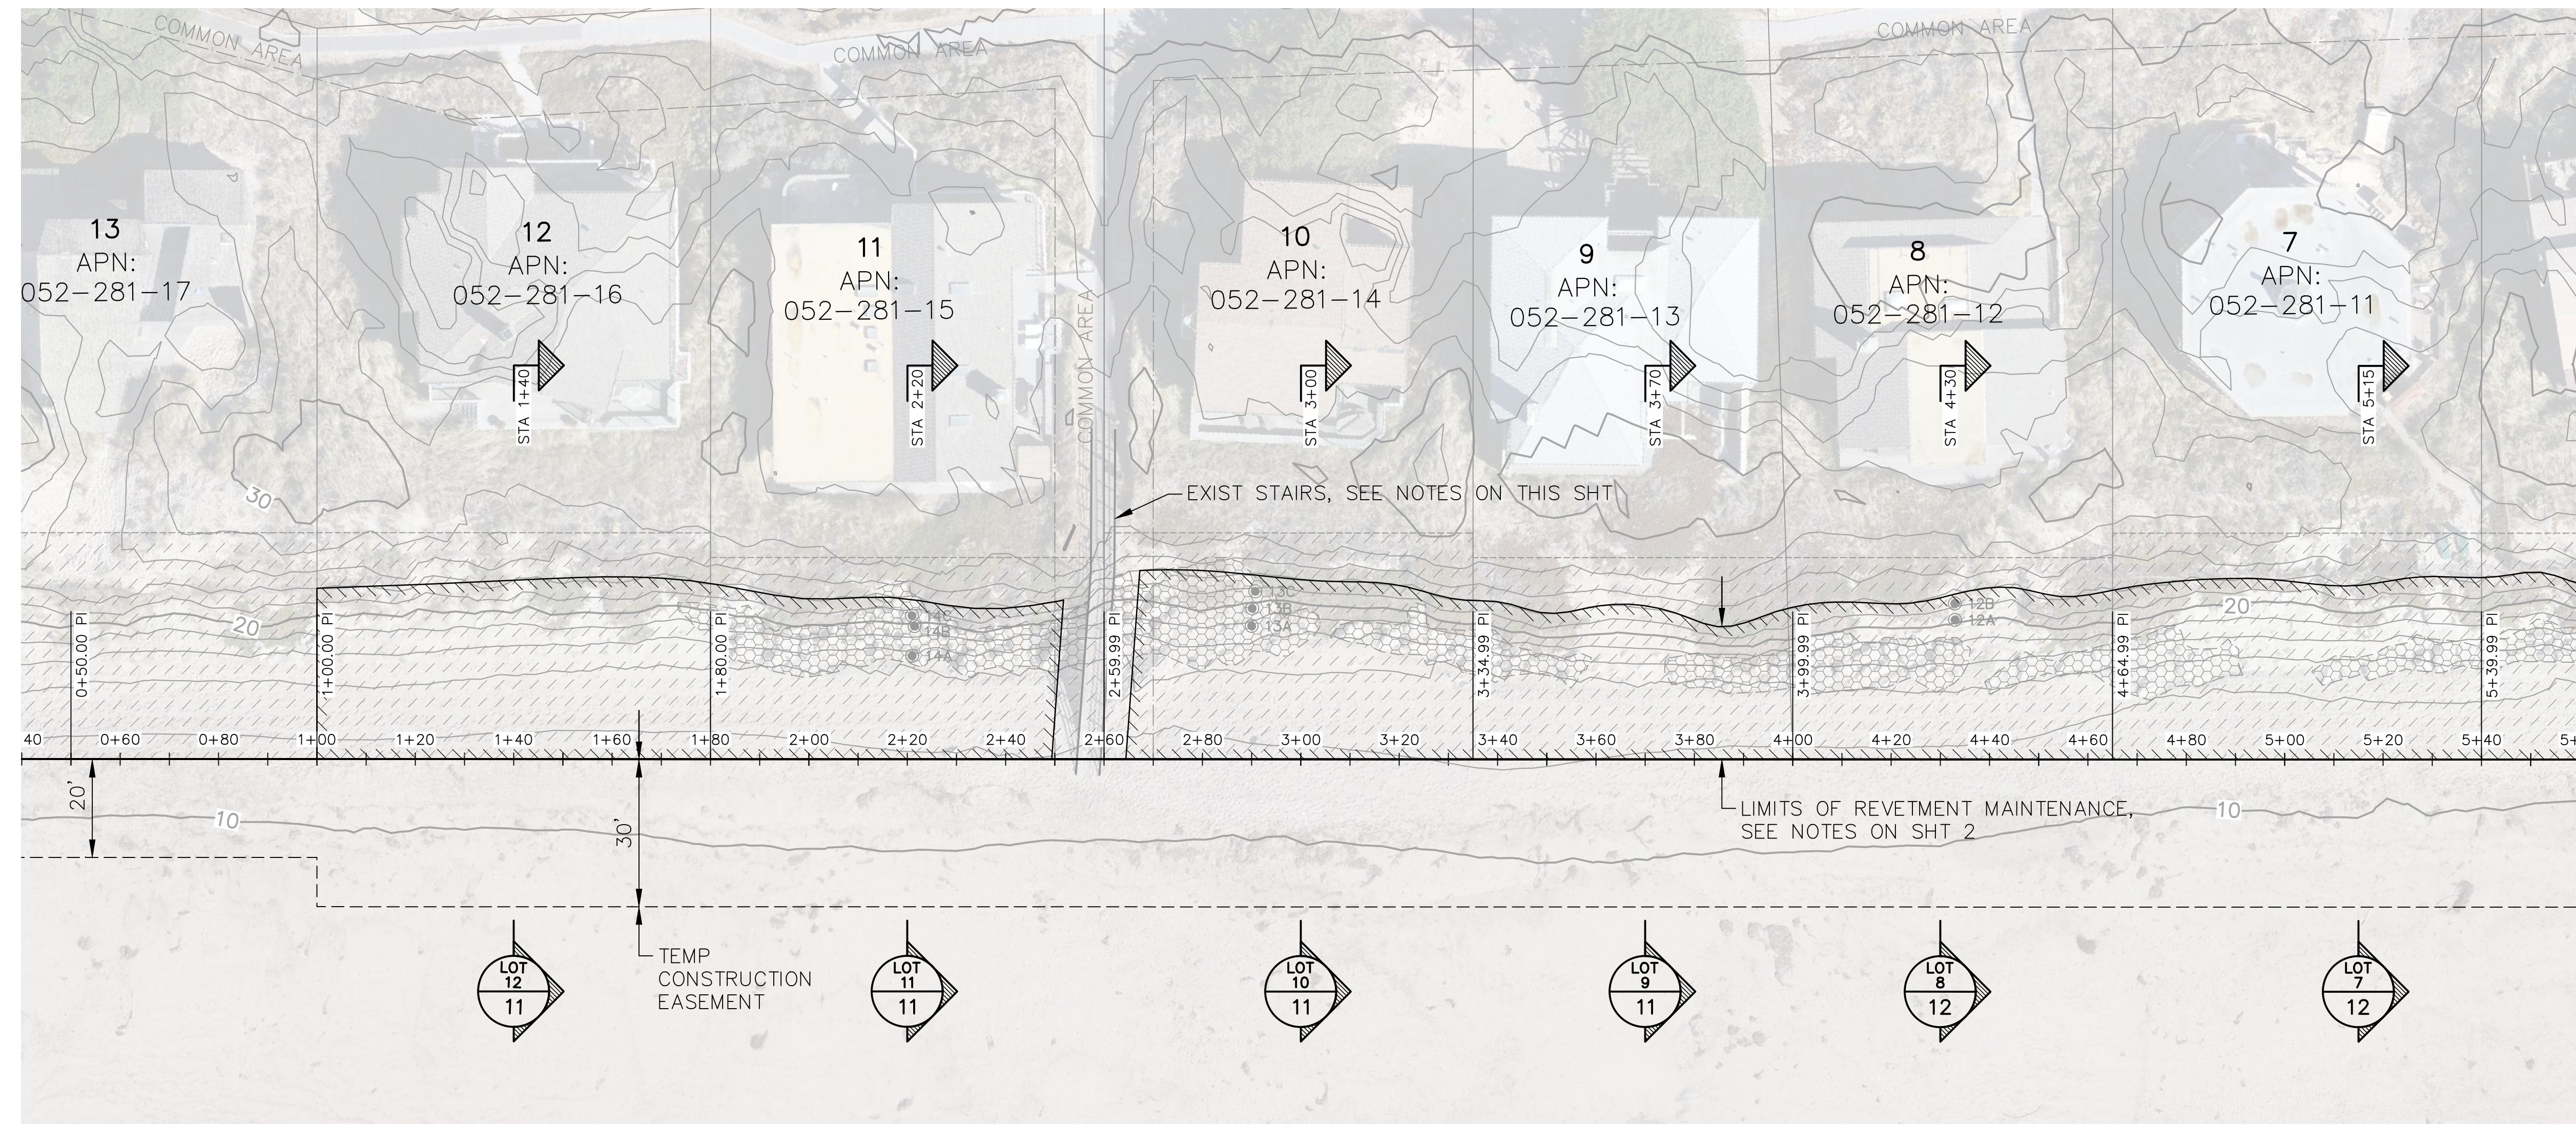
- THE KNOWN LOCATIONS OF THE BURIED EMERGENCY-PLACED ROCK ARE IN THE FOLLOWINGS LOCATIONS:
1. ON STATE PARKS PROPERTY IN FRONT OF THE REVETMENT TOE ADJACENT TO LOTS 98, 99, 100, AND 103. TOTAL OF APPROX 440 TONS.
 2. ON PAJARO DUNES PROPERTY OVERLYING THE ROCK REVETMENT TOE ON LOTS 15, 54, 55, 103, AND 104. TOTAL OF APPROX 235 TONS.

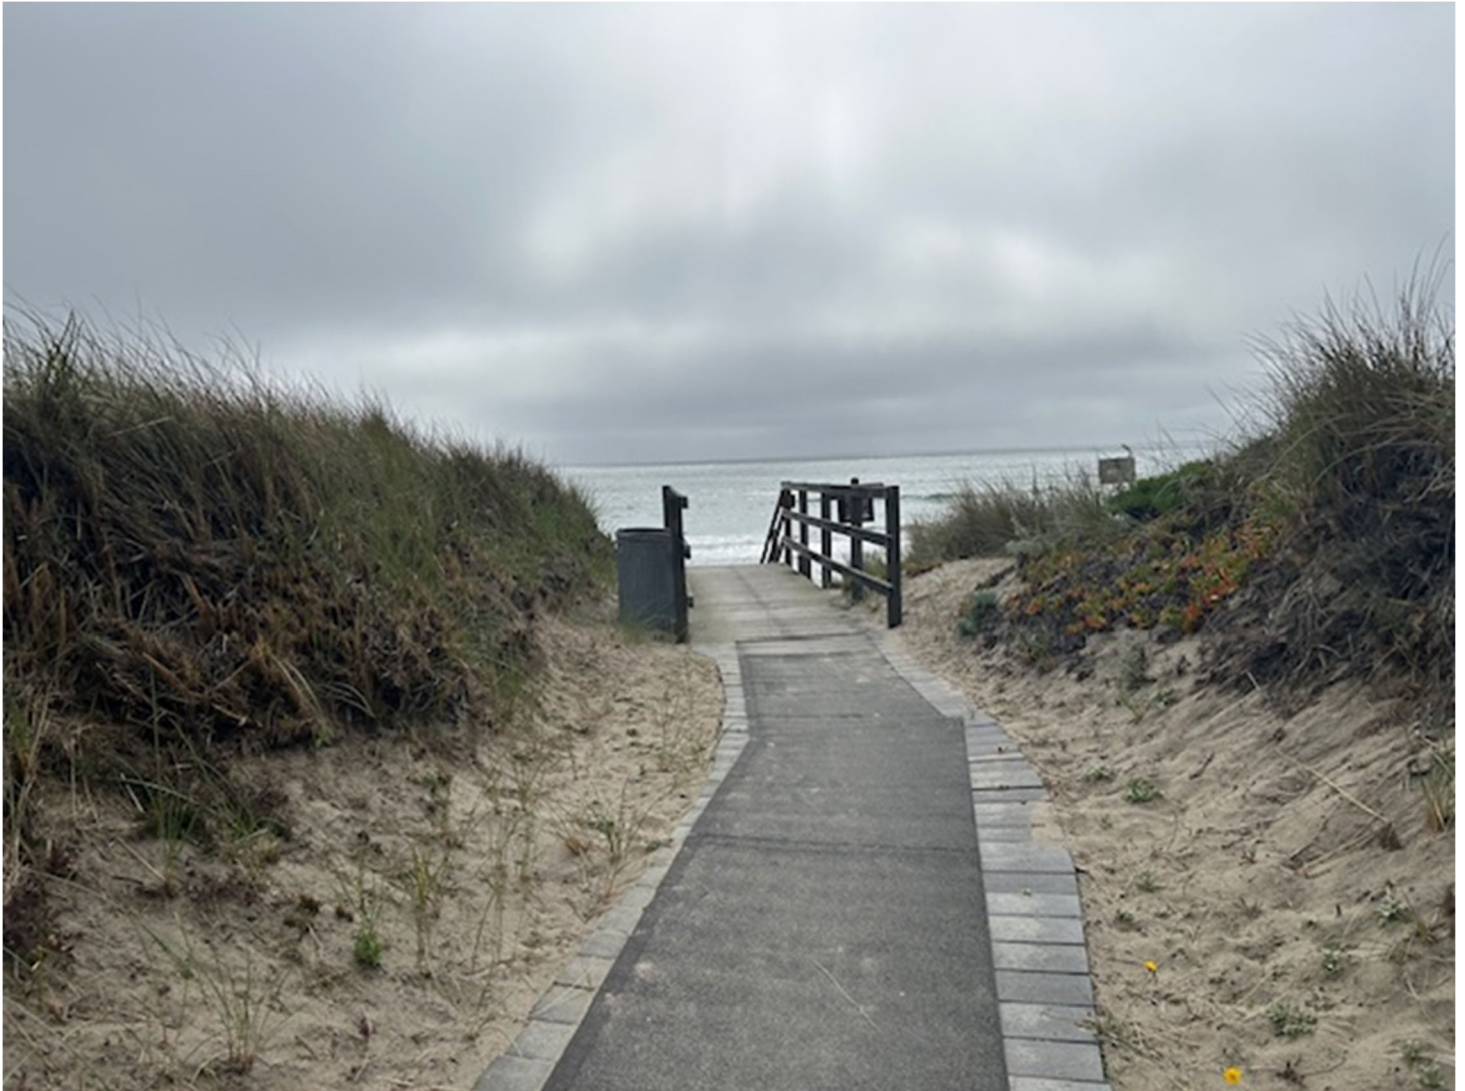
Photograph 4: Looking West at stairway within Project Area boundaries with Monterey spineflowers (*Chorizanthe pungens* var. *pungens*) growing on the sides of walkway.

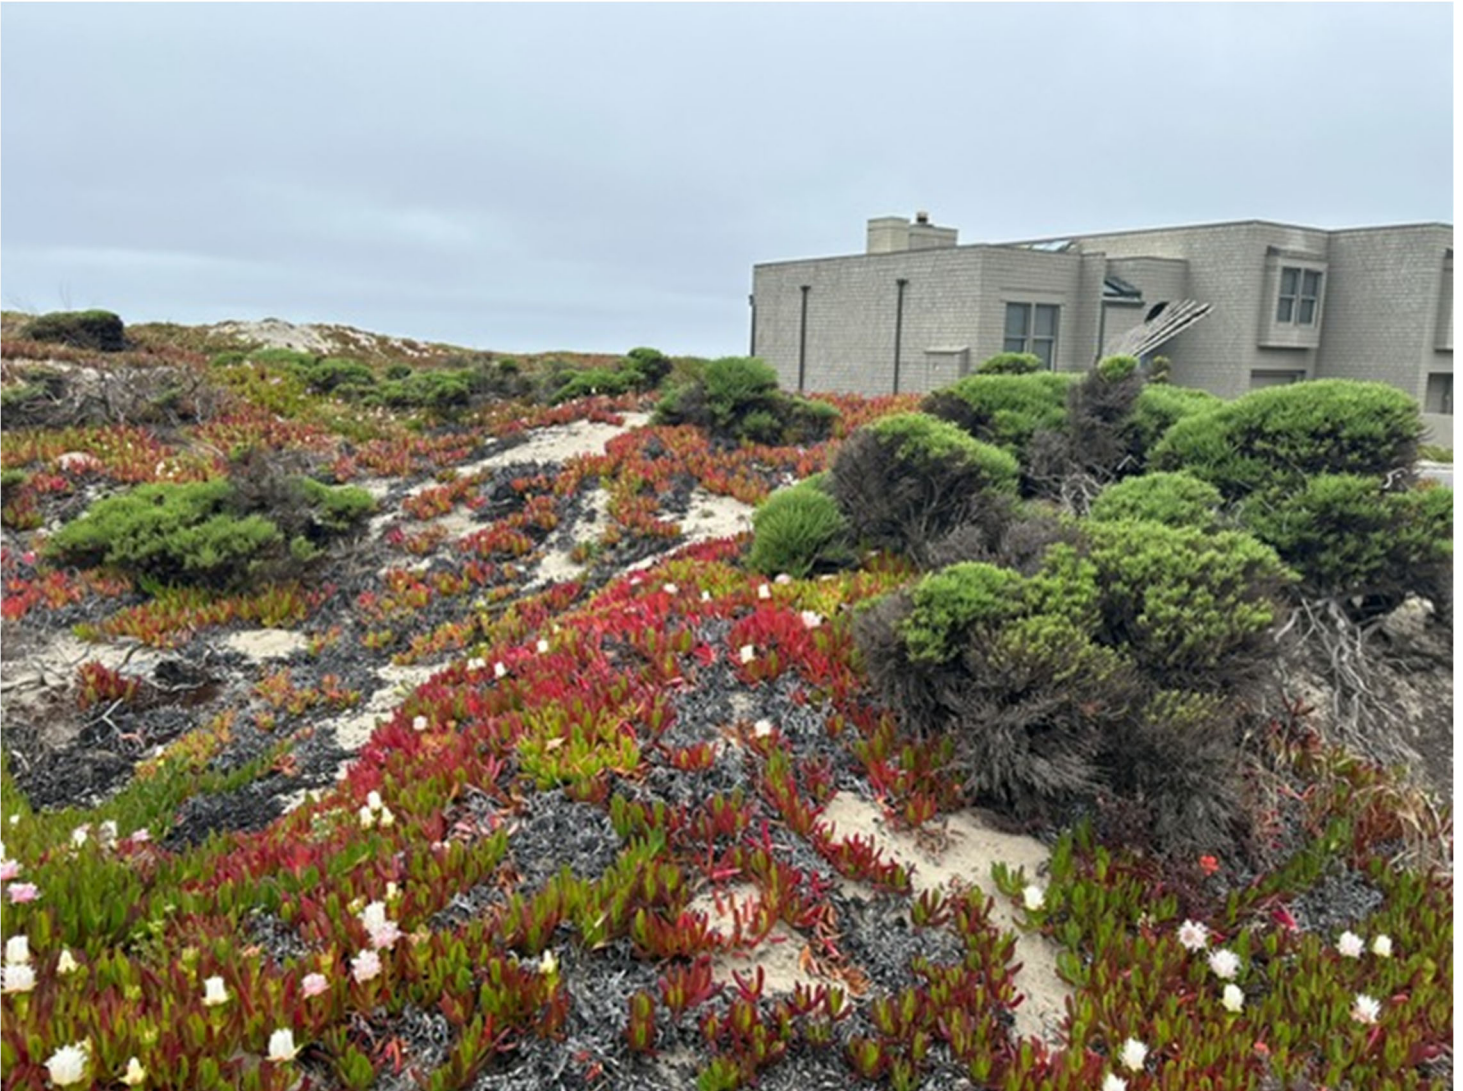
Photograph 5: Looking West at proposed laydown area with the largest population of Monterey spineflowers (*Chorizanthe pungens* var. *pungens*).
